# Greg Braley Home Inspections

## CONFIDENTIAL INSPECTION REPORT

### INSPECTION ADDRESS

7/5/2006

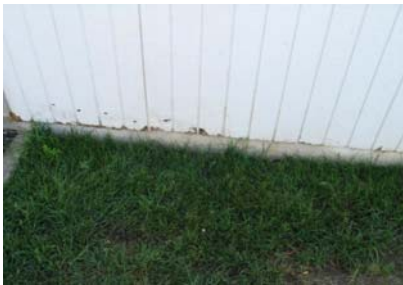
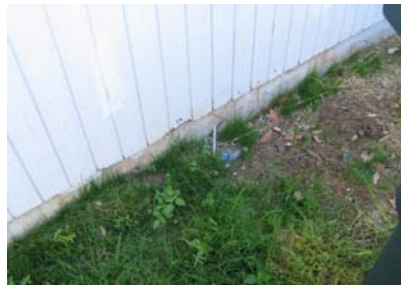
- \* Portions of the siding are moisture damaged, and should be evaluated and serviced as necessary by a termite inspector.

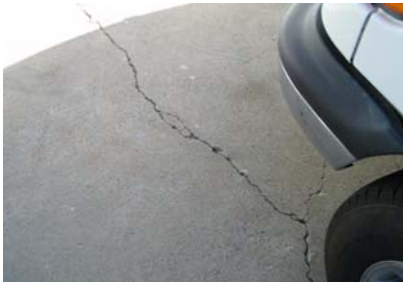
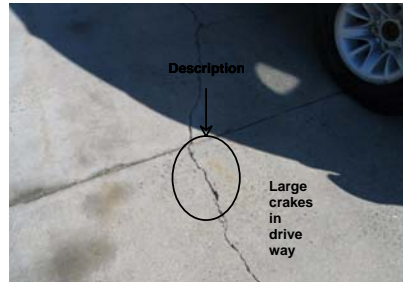
- \* There are predictable cracks in the driveway that would not necessarily need to be serviced.

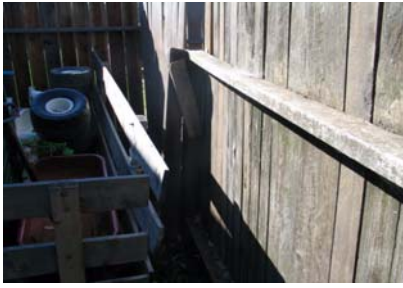
- \* Sections of the fence are leaning or damaged and should be repaired or replaced.

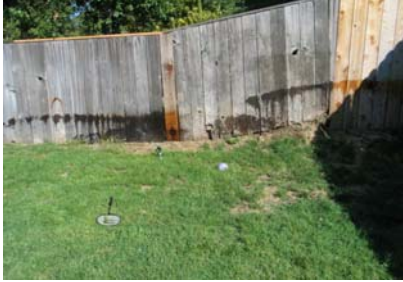
- \* Sections of the fences or gates are dry rot or termite damaged. However, you may wish to confirm that they have been included in the termite inspection.

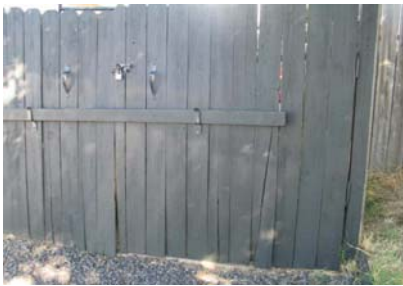
- \* The gate needs to be serviced to be functional.

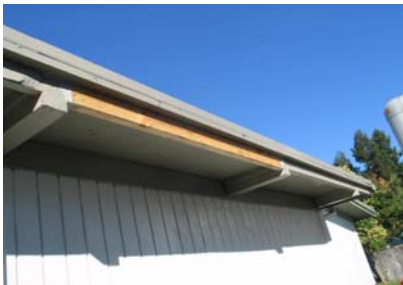
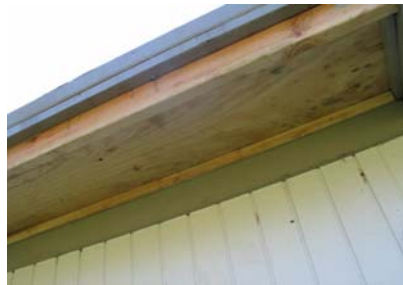
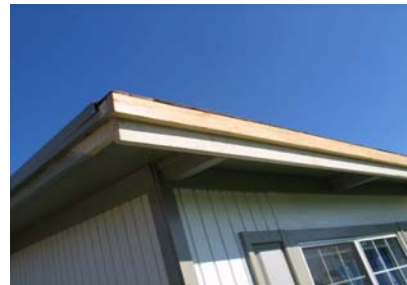
- \* The termite report should confirm damage to portions of the fascia board and wood trim.

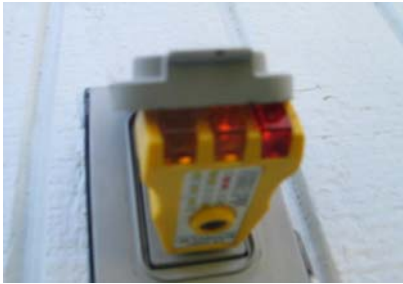
- \* An outlet in the rear of the house is defective but should be upgraded to have ground-fault protection.

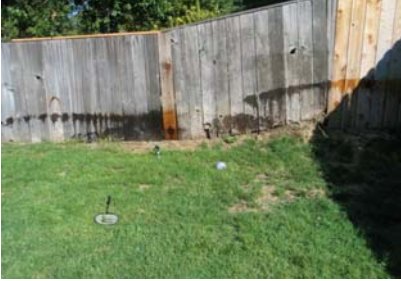
- \* The property is served by manual, polyvinyl, sprinklers. The coverage appears to be adequate. However, the heads

need to be adjusted so as not to over spray the house walls and other surfaces.

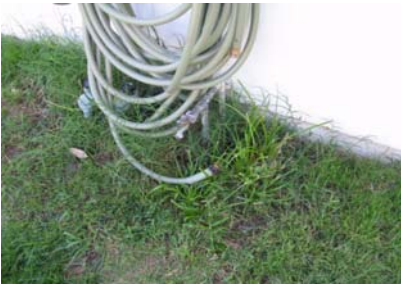
- ❖ A hose bib at the rear is dripping and needs a new stem washer. However, we may not have located and tested every hose bib on the property.

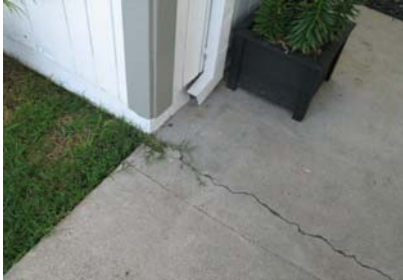
- \* It would be prudent to have splash blocks installed at the bottom of the downspouts, to divert water away from the house and its foundation.

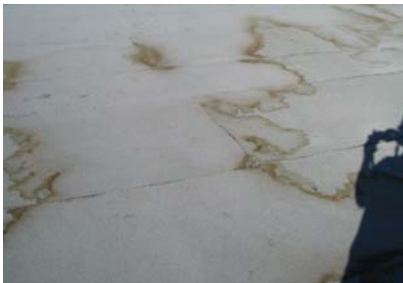
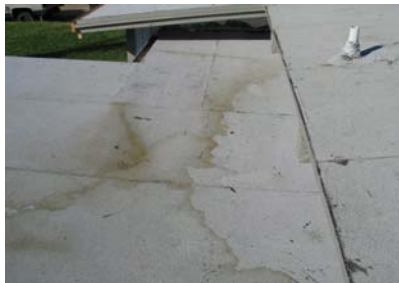
- \* For the following reasons, the roof or its components need to be serviced by a licensed roofing contractor before the close of escrow. Their are low spots at the roof that collect water in heavy rains.

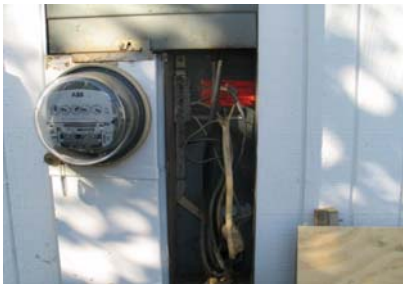
- \* Various circuits within the main panel are not labeled but should be, so that the appropriate load calculations and breaker sizes could be determined.

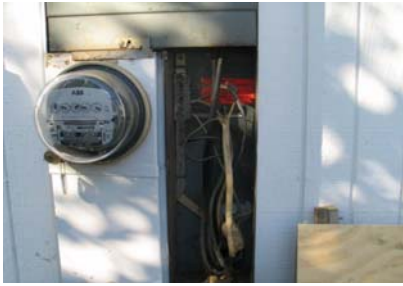
- \* The exterior cover for the main electrical panel has loose or missing hinges, and should be serviced.

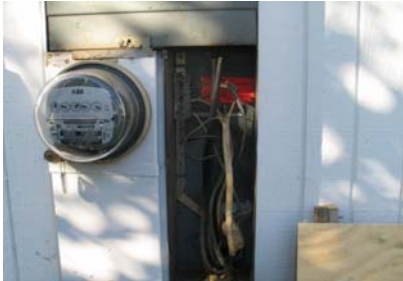
- \* The electrical system includes suspect aluminum wire, but which has been copulum crimped. However, you should obtain the permit or documentation from the sellers that would reveal the extent of the work.

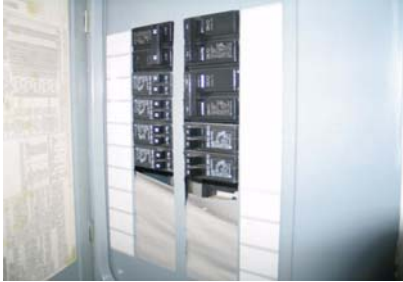
- \* Various circuits within the sub-panel are not labeled, and should be serviced by an electrician so that the appropriate load calculations and breaker sizes could be determined.
- \* The sub-panel is unconventionally located inside a closet, which would not be permitted by current standards. Therefore, you may wish to verify its installation permit or have an electrician evaluate.

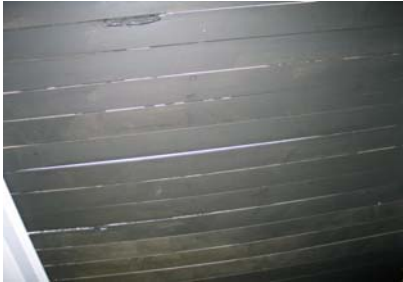
- \* The surface is rough and should be explained by the owner

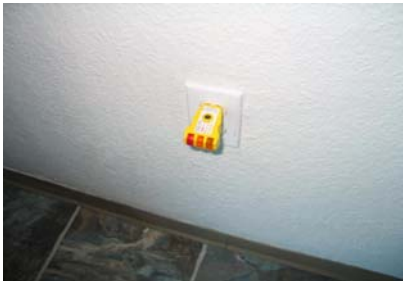
- \* An outlet has a hot-ground reverse, and should be serviced.

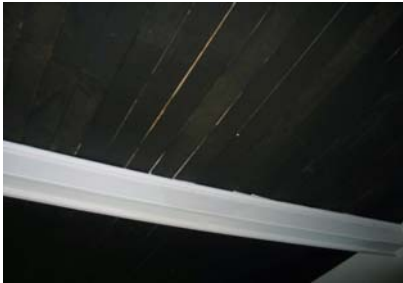
- \* The walls and ceiling in the bedroom are in acceptable condition. The ceiling is rough and should be explained by the owner.

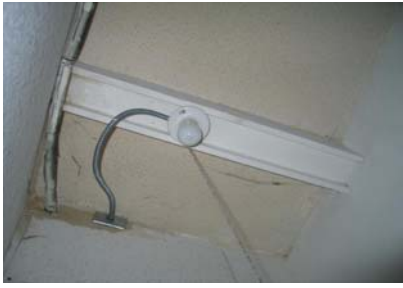
- \* The bedroom closet employs an incandescent light bulb that should have a cover.

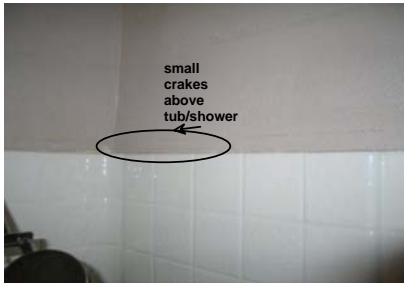
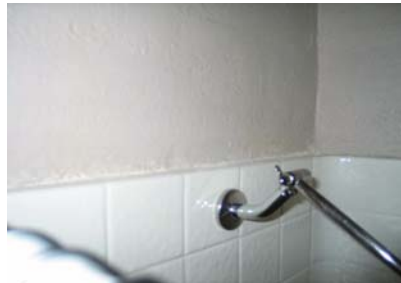
- \* There are stress fractures in the walls that have resulted from movement. Such cracks can reappear if the movement is caused by expansive soils, and particularly if the cracks are not repaired correctly. However, only a geologist could predict the likelihood of further movement.

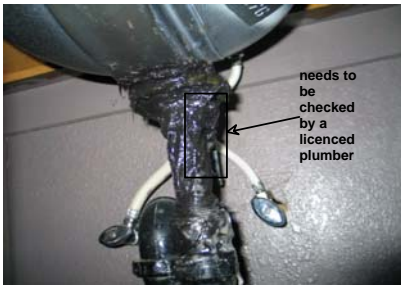
- \* The bathroom sink drain lines are either negatively pitched, make unnecessary turns, or have had amateur repairs, and should be serviced by a professional. The drain at the sink shows signs of non professional repair and should be checked by a licenced plumber
